Inspection Report

Property Address:
12345 Main Street
Phoenix AZ 85001

G&L Home Inspections

Date: 6/26/2019	Time: 09:00 AM	Report ID: Sun 6-26-19
Property: 12345 Main Street Phoenix AZ 85001	Customer: Michael Sun	Real Estate Professional: Margaret Wilson

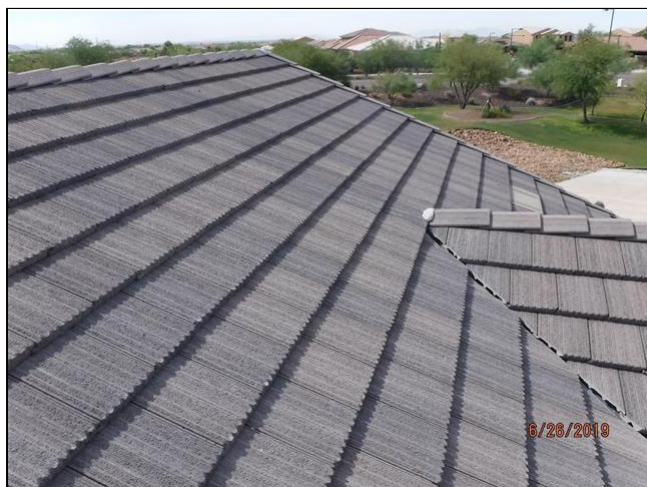
1.0 Item 1(Picture)

1.0 Roof Coverings

Tile Roof

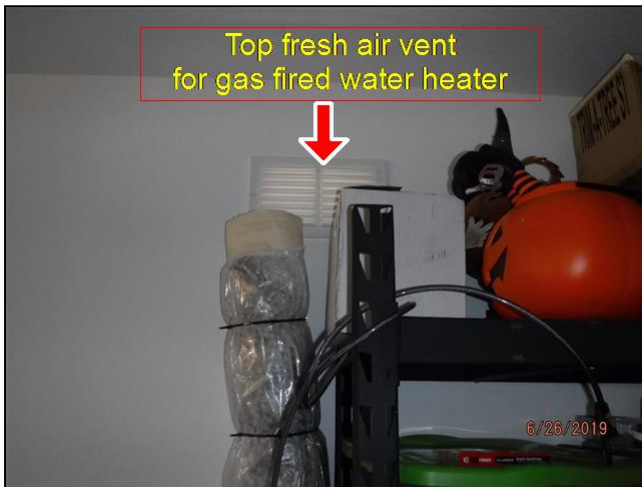
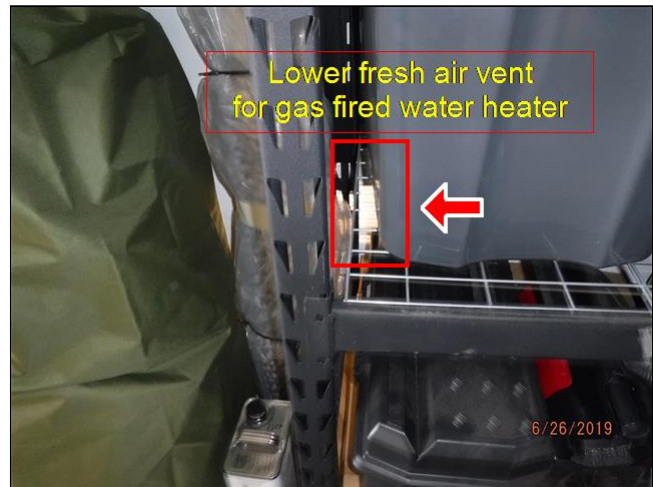
3.1 Item 1(Picture)

3.1 Garage Walls (including Firewall Separation)

Fresh air vents (upper & lower) installed for gas fired water heater.

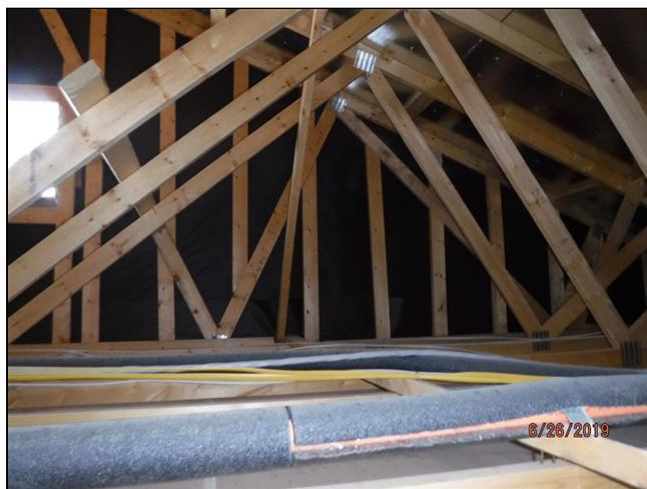
5.4 Item 1(Picture)

5.4 Roof/Ceilings Structure

Truss framing in good shape

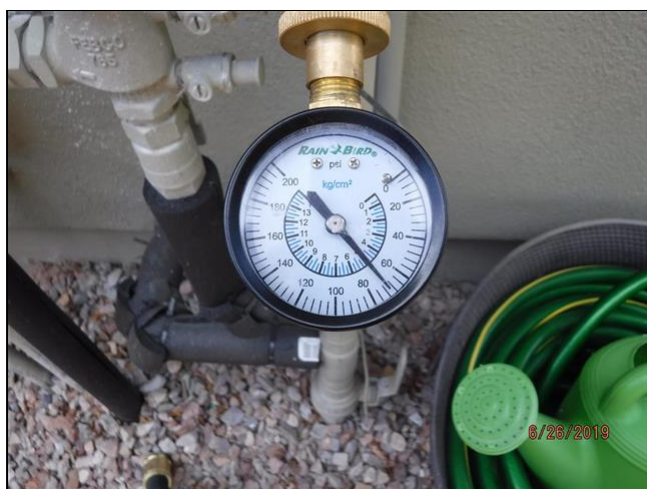
6.1 Item 1(Picture)

6.1 Plumbing Water Supply, Distribution System and Fixtures

Water pressure is approximately 69 psi.

Washing machine has stainless steel hoses

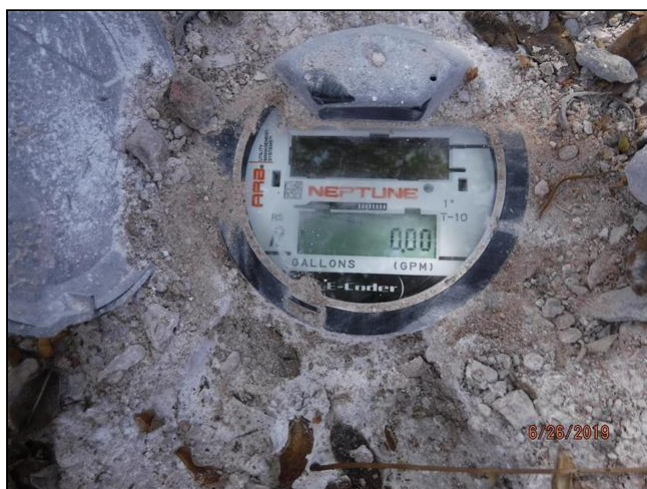
6.2 Item 1(Picture)

6.2 Water Supply Leaks

Meter reads zero flow as it should be when house in not occupied.

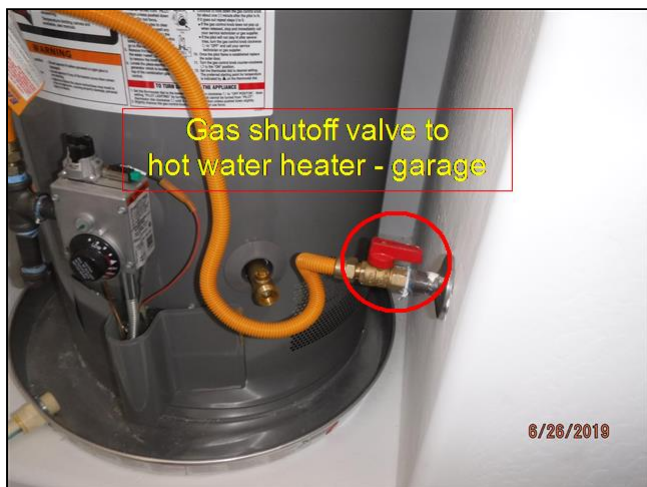
6.3 Item 1(Picture)

6.3 Hot Water Systems, Controls, Chimneys, Flues, Vents, TPR Valve and Thermocoupler

Comments: Inspected
Gas shutoff to water heater.

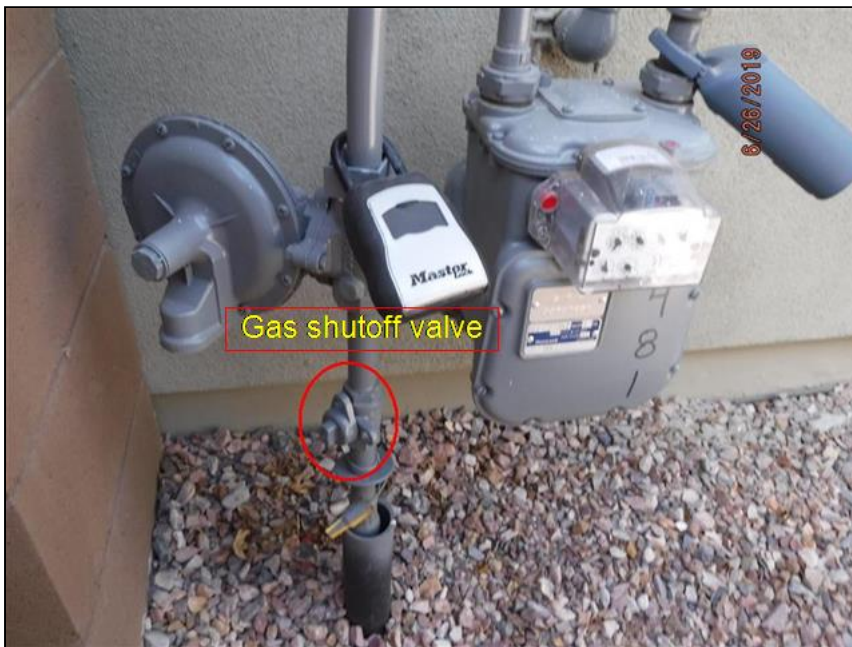
6.5 Item 1(Picture)

6.5 Fuel Storage and Distribution Systems

Gas shutoff is located on the South exterior wall.

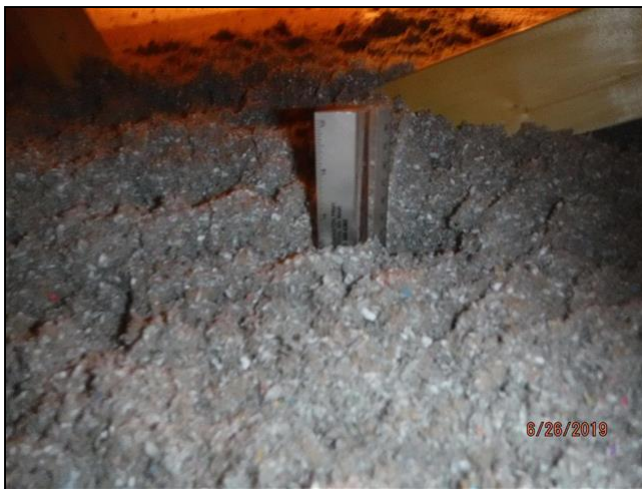
9.0 Item 1(Picture)

9.0 Insulation in Attic

Blown-in insulation - ten (10) inches.
